Feasibility Testing Report – Lower Attachment Stage 1

Team: P15001: Active Ankle Foot Orthotic

Test Date: 10/16/2014

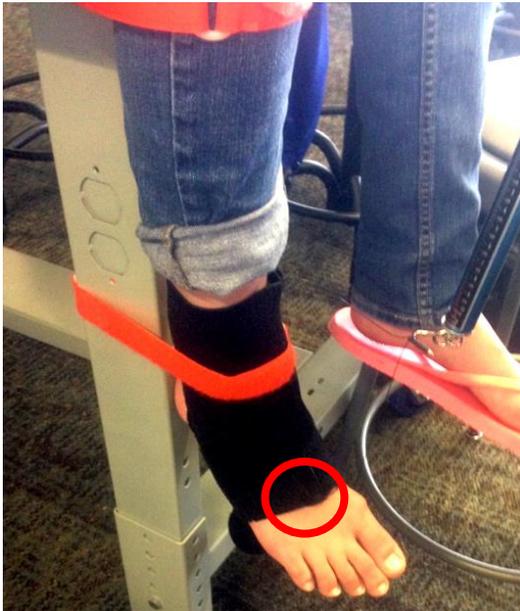
Setup 1: In this setup, the volunteer is wearing an ankle brace with a piece of fishing line sewed into the end of the brace. The volunteer's leg is held to the base of a table using 2 Velcro straps, one placed right above the volunteer's ankle and another placed around the mid calf region. This ensures that the volunteer's leg remains still during the test in order to obtain the most accurate force values.

Figure 1: Setup #1, fishing line attached at end of brace (see circled area).

Setup 1: The collected results for setup 1 are displayed in table 1, below.

- 1.) Brace is crimping because most of the force absorbed by brace
- 2.) First 1.5lbs of force is transmitted to brace
- 3.) Moment arm at start of test: 4.75inches, Moment arm at end of test: 2.9inches

Trial	Force (lbs)
1	7.5
2	8.0
3	8.5
Average	8.0

Note: The volunteer indicated that their foot was only lifted approximately 60% of the way. An angle of 90 degrees was NOT obtained during this test.

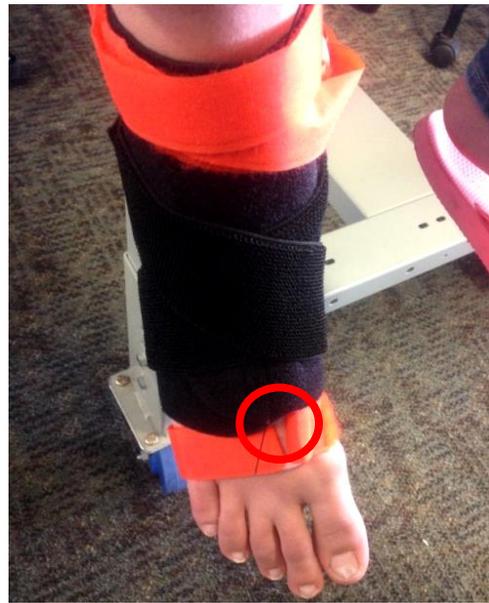
Setup 2: In this setup, the volunteer is also wearing an ankle brace with a piece of fishing line sewed into the end of the brace; however, the force is not applied on the brace directly. The fishing line on the brace is tied to a rigid Velcro strap that is wrap around the

volunteer's foot, near the toes. Another piece of fishing line is tied to the Velcro strap and will be used to apply a force. Similar to setup 1, the volunteer's leg is tied to the base of a table using 2 Velcro straps, one placed above the volunteer's ankle and another placed around the mid calf region. This ensures that the volunteer's leg will remain still during the test in order to obtain the most accurate force values.

Figure 2: Setup #2, fishing line attached to the Velcro strap that is tied to the ankle brace (see circled area).

Setup 2: The collected results for setup 2 are displayed in table 2, below.

Trial	Force (lbs)
1	7.0
2	6.75
3	7.0
Average	6.91

Note: the volunteer noticed that during this particular setup, the foot was lifted to 90 degree angle
