## Feasibility Testing Report – Corrosion Test

*Team: P15001: Active Ankle Foot Orthotic*

**Test Date:** 03/10/2015 & 03/12/2015

### **Related System:** ABBBB: Raise Foot

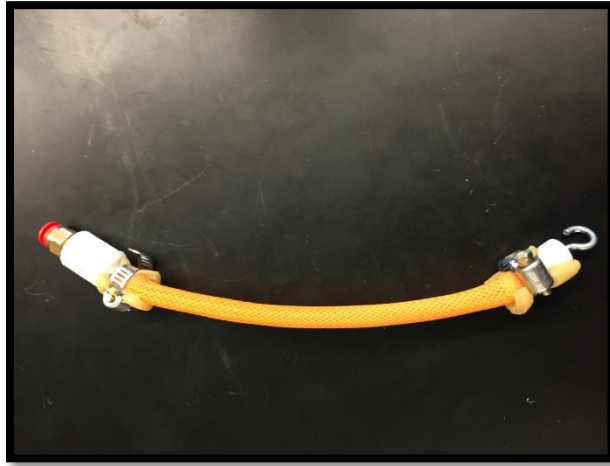
Muscle contraction

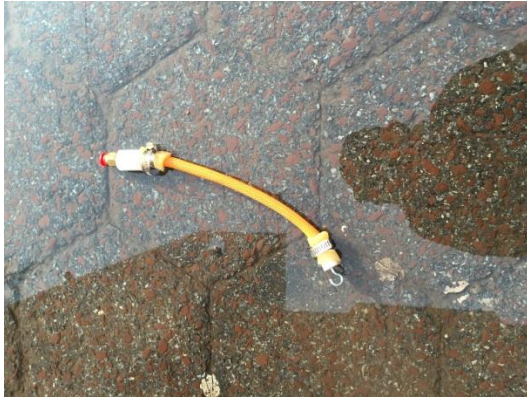
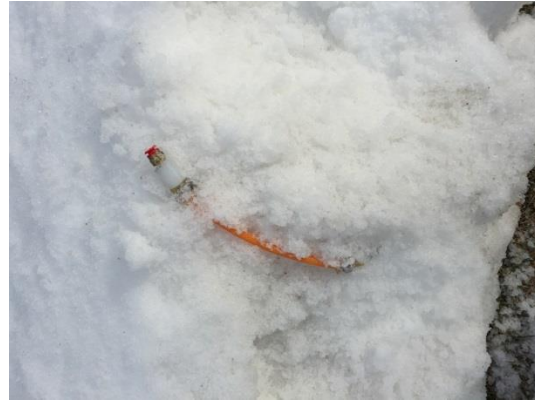
Pictures of Testing:

It was decided that, instead of submerging the muscle into salt water or putting it in a freezer, we would instead expose the muscle to actual environmental conditions for the Rochester climate. A sample muscle was constructed and was then taken on a "walk" around the RIT campus, exposing the muscle to 2 snow piles, as well as 5 salt water puddles. These are potential environmental conditions that the AFO would see throughout a day. The muscle components and performance was compared before and after the test.

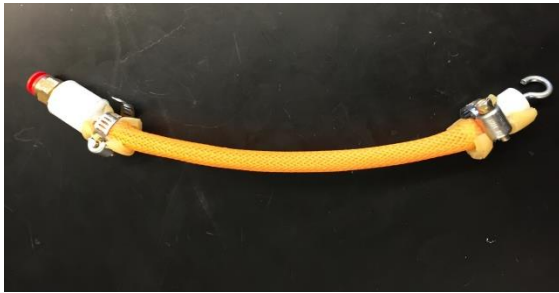
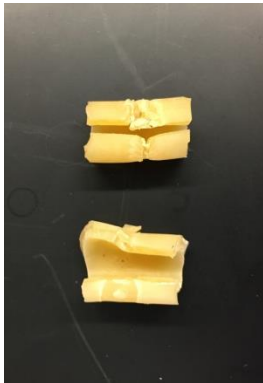
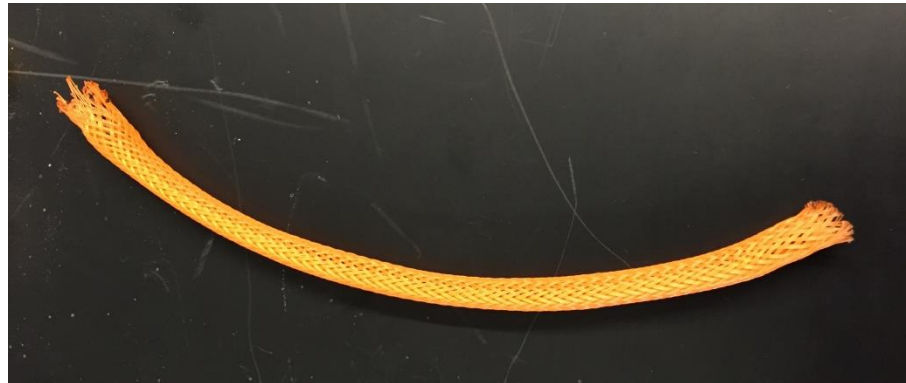
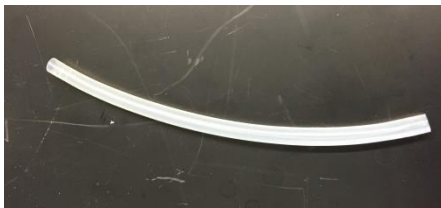
Before:

Comparison of Components Before and After:

When comparing the muscle and its components before and after testing, there were no noticeable defects that would affect the muscle performance. There was some dried salt on the muscle components, most notably the metal clamps and air port, but it was nothing that would seriously affect performance. Also, there was no rust present on the metal components.
