Feasibility Testing Report – Strength Test

Team: P15001: Active Ankle Foot Orthotic

Related System: ABBBB: Raise Foot

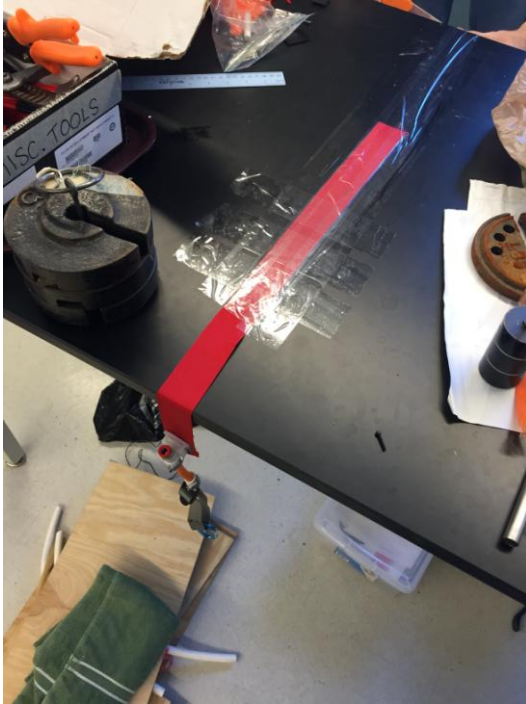
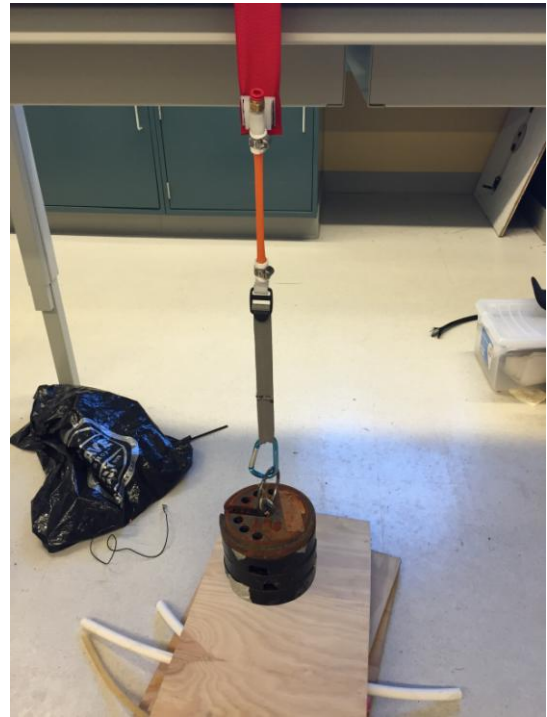
Basic Test Set-Up

1. Construct a nearly identical McKibben muscle to be subjected to rigorous testing
 - a) Use identical materials used in our McKibben muscle; i.e., silicon, sheathing, plastic plugs, etc.
2. Sew muscle base to red inelastic support to mimic actual brace set-up
3. Suspend muscle from table and attach red inelastic ribbon securely to the table via packing tape
4. Add weights to the muscle rig, note any deflection, failure, or other things worth note.
5. Add up to 30lb and then attempt to drop the maximum weight to simulate impact forces.

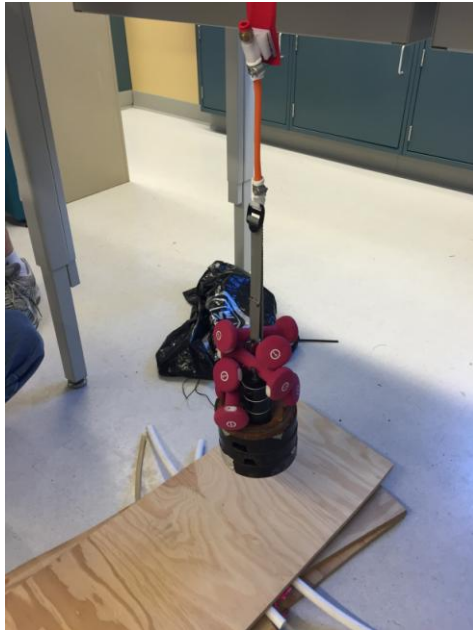
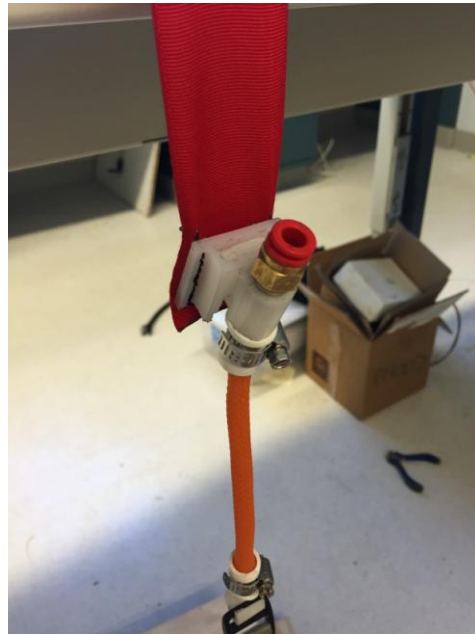
Pictures of Testing:

The muscle successfully supported 30 lbs of vertical force with no apparent signs of deflection or failure.

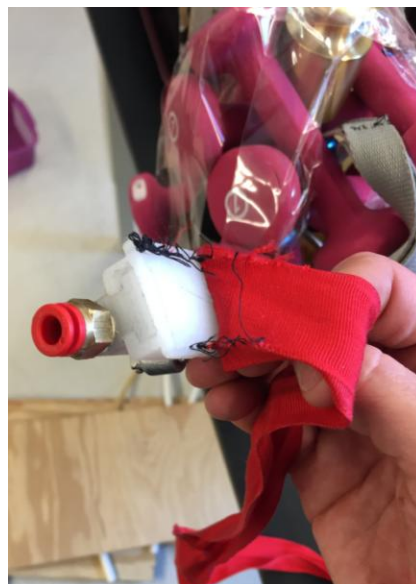
Muscle base and red inelastic ribbon after failure

When impact testing was ready to be performed, the red inelastic ribbon actually slipped off the table and pulled away from the packing tape. A group member elected to simply hold the weights by the ribbon with their own hand but in the process the red ribbon was pulled with at an unusual angle and as a result, tore away from the muscle base.

- a.) Muscle and components supported the weight of 30lbs without failure or noticeable deflection. This corresponds to a factor of safety of about 3 for a max design lift of approximately 10lbs.
- b.) Failure occurred between the inelastic ribbon and the muscle base after a considerable amount of force was applied at an unusual angle near the upper muscle base.
